Insight Home Inspections, LLC.

HOME INSPECTION REPORT

Inspection Time: 9:00am Description of Home
Single Family X
Town House
Villa
Condo
Duplex
Configuration:
Home occupied at time of inspection: Yes X No No
Year Built: 2013
Total Square Feet:
Date of Last Significant Rainfall: >1 week < 1 weekX
Comments:

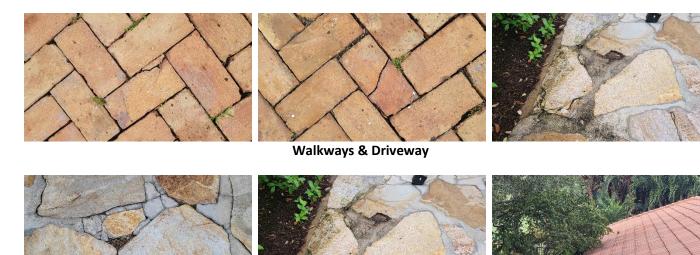
- 1 & 2. Cracked, Damaged & Uneven pavers noted on Walkways & Driveway.
- 4. Damaged stone pavers noted around pool area.
- 8. Overhanging trees noted on left side of dwelling / making contact with roof.
